TECHNICAL UNIVERSITY OF CRETE
SCHOOL OF ELECTRICAL AND COMPUTER ENGINEERING

Study of Dielectric Strength of High Voltage Cables

Diploma Thesis

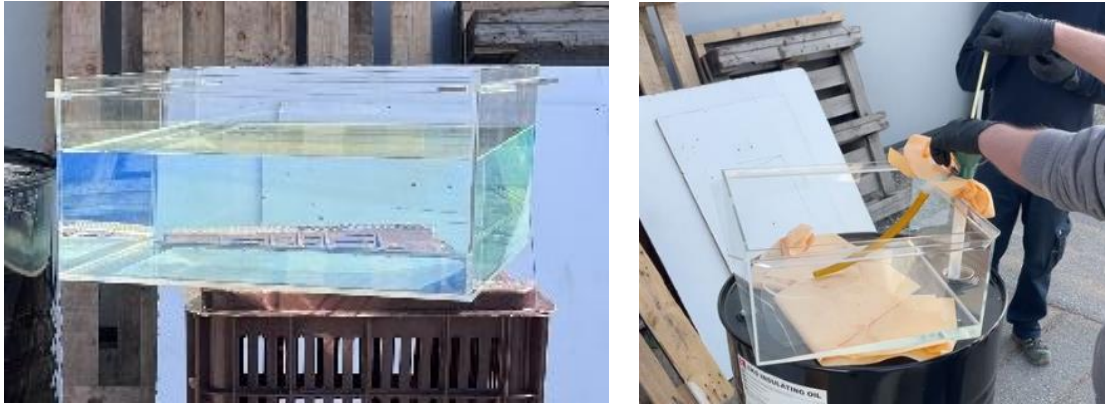
Figure 8. Oil filling with manual pump.

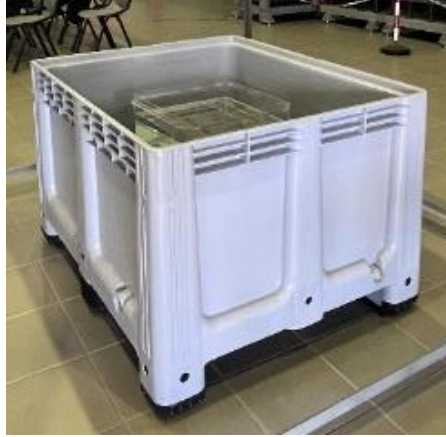
Figure 12. Outer protective box.

The entire stack is placed in a 1000ℓ high-density polypropylene intermediate bulk container that fulfils three roles simultaneously: tertiary containment, mechanical support and acts as a mobile trolley (Figure 12). Since this system was adopted for more than thirty voltage impulses with magnitude up to 450 kV, without any structural damage, the assembly satisfies all operational requirements: dielectric withstand, visual accessibility, ease for cleaning and, crucially, mechanical resilience under repetitive breakdown duty.

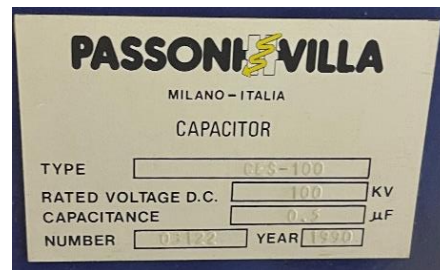
Figure 14. Charge capacitor data label.

Charge capacitors are responsible for providing output energy to the tested specimen. Passoni-Villa's generator used is equipped with 5 capacitors, that make up the generators capacitor bank. The capacitors' data label is shown in Figure 14. The label shows that each capacitor has a maximum charge level of 100kV and a capacitance of 0.5 μ F, so the final total energy (E) that this Marx generator can provide is given using the equation (3).

Where C_{total} is the total capacitance of the Marx generator. Using (3) and the nominal values of the capacitors, the total energy was calculated 12.5 kJ.

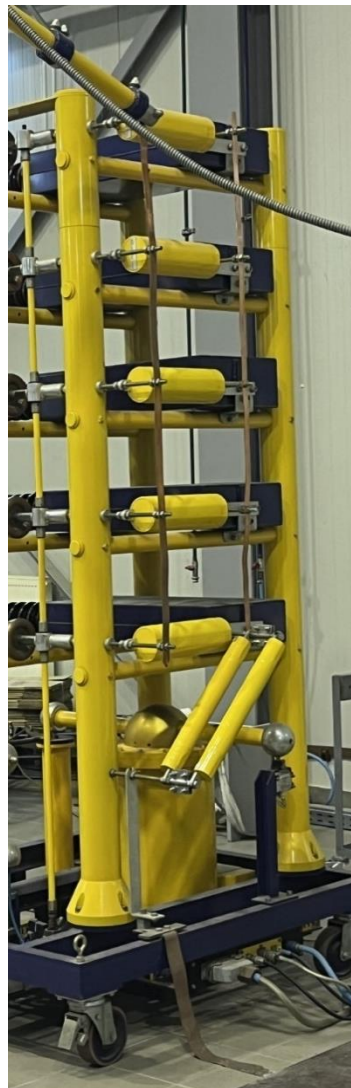
Figure 22. Tail and front resistors repositioned.

According to the manufacturer, the tail resistors, which were originally distributed across individual stages, should be removed from their initial positions and should be reconnected as a parallel network downstream in the discharge circuit. This parallelization effectively lowers the overall tail resistance. The reduced tail resistance preserves the desired tail time—approximately $50\ \mu\text{s}$ —ensuring the voltage decay of the impulse remains within IEC 60060-1 specifications. Simultaneously, the front resistors, which shape the front time of the impulse waveform, were readjusted in the new configuration. As the equivalent capacitance increased with the parallel connection of capacitors, the front resistor values were modified, to maintain the targeted front time near $1.2\ \mu\text{s}$, as shown in Figure 22 [5].

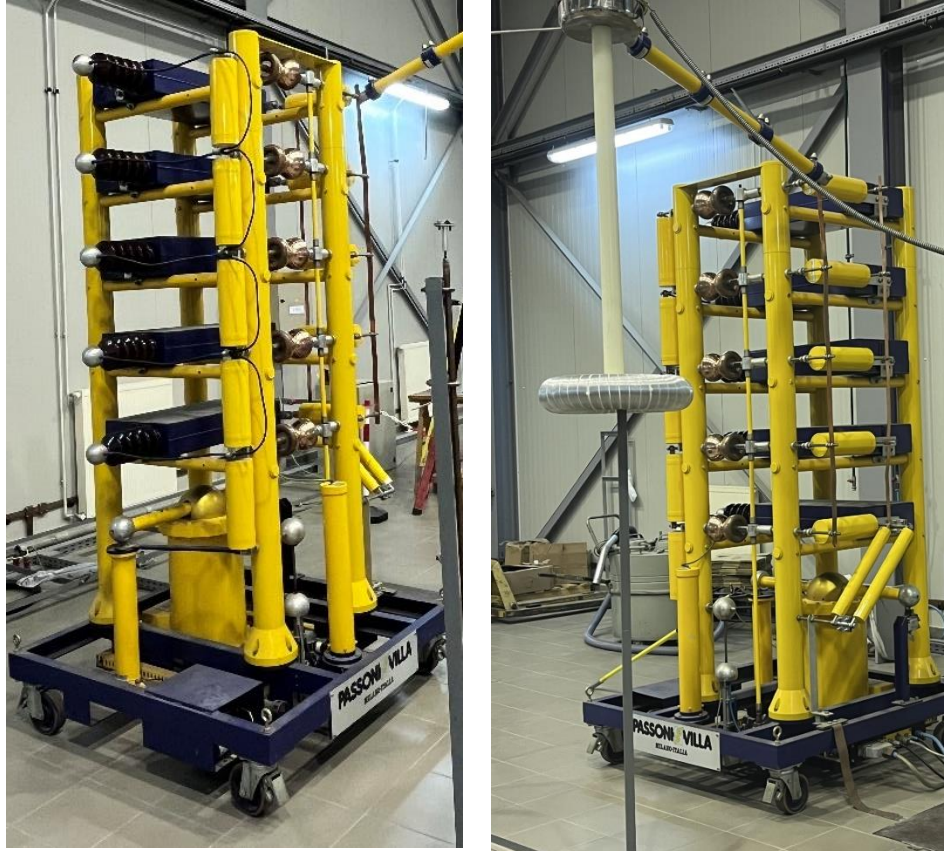
Figure 24. Fully assembled single-stage voltage impulse generator.

Finally, the fully assembled and modified generator, installed in the laboratory environment is depicted in Figure 24. The finalized circuit is depicted in Figure 25.

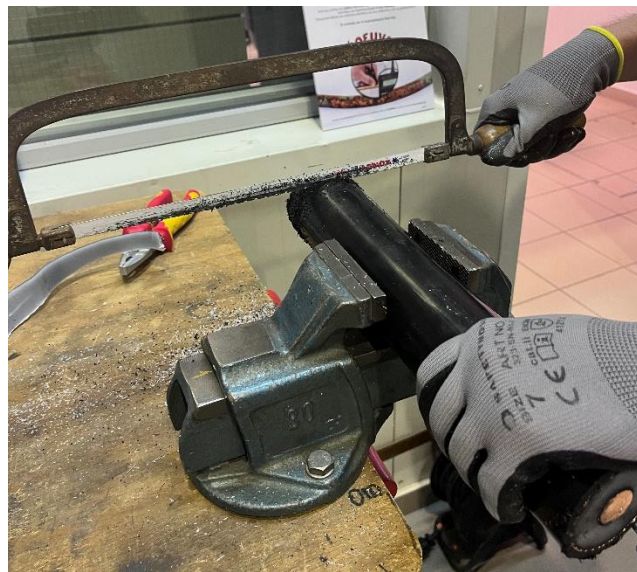
Figure 28. Saw and slicing procedure.

To expose the underlying copper sheath to install ring and testing leads on one end of the specimens, the factory-applied graphite jacket was removed mechanically with basic hand tools. The entire operation takes three to five minutes per cable end and avoids heat or rotary cutters that might drive graphite particles into the polyethylene. A 35 cm cable section is secured horizontally in an 80 mm bench vice (Figure 28), the jaws tightened only enough to grip the HDPE jacket without ovalising the core. A fine-tooth hacksaw is used to score a swallow 360° groove around the jacket at the prescribed strip line (Figure 28). The blade is kept square to the surface, and cutting ceases as soon as the bright spiral of copper wires becomes visible.

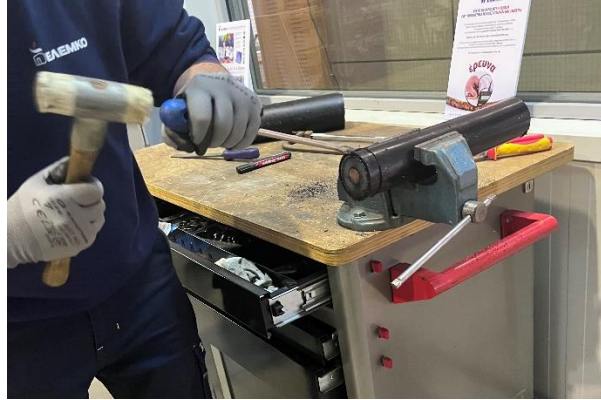
Figure 29. Jacket ring removal tools and procedure.

With the circumferential groove complete, the hacksaw is guided along the cable axis to open a single longitudinal slit from the score line to the sample end. This produces a tongue of jacket that can be lifted without nicking the copper screen. A flat-bladed screwdriver is then inserted into the slit and tapped gently with a raw-hide mallet (Figure 29); the soft face prevents impact damage to the insulation while the screwdriver acts as a wedge, gradually raising the graphite layer away from the HDPE.

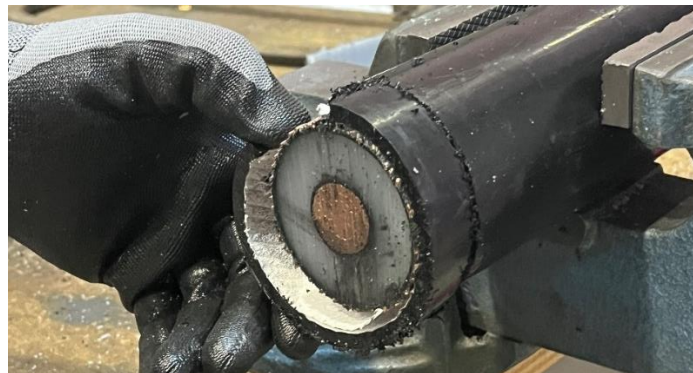
Figure 30. Jacket ring.

Once a sufficient flap has been freed, the jacket is peeled off in a smooth, circular motion (Figure 30). If resistance is felt, the longitudinal cut is extended in short increments rather than forcing the peel, thereby avoiding gouges in the copper screen. Residual graphite dust is wiped away with isopropyl-alcohol, leaving a clean oversheath surface ready for corona-ring installation and impulse-withstand testing.

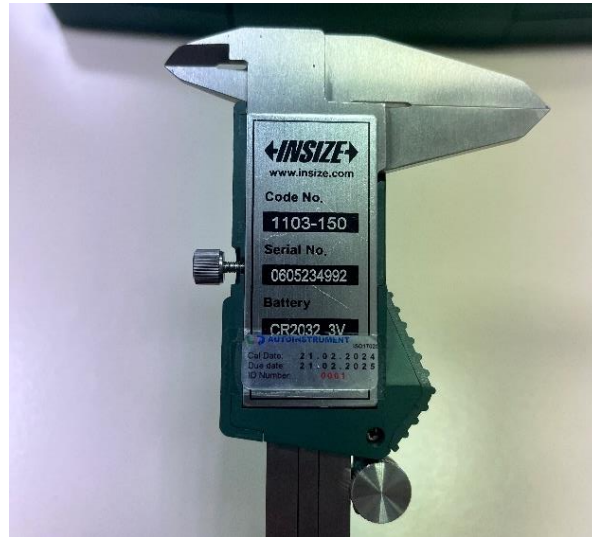
Figure 31. Vernier caliper for thickness measurement.

Once the graphite-loaded jacket has been peeled away, a narrow band of the exposed HDPE oversheath. The band is cut with a fine saw while the cable remains in the bench-vice, ensuring that the cut faces are perpendicular to the cable axis and that the ring is not distorted. A digital vernier caliper (Figure 31) is zero-calibrated and used for thickness measurements. The ring is positioned lightly between the jaws so that the measurement axis is radial. Ten readings are taken at points roughly 36 degrees apart around the circumference, beginning with the thinnest visible

location and rotating the ring between successive measurements. Each value is recorded to the nearest 0.01 mm in the specimen log. With these measurements the arithmetic mean is calculated.

The measured ring is finally sealed in a labelled bag and attached to the test dossier, providing traceable physical evidence of the oversheath-thickness check. Care is taken throughout to handle the ring only with clean nitrile gloves and to keep the caliper jaws exactly parallel to the ring faces, thereby avoiding surface contamination and cosine-type measurement errors. The results of the measurements are shown in Table 5.

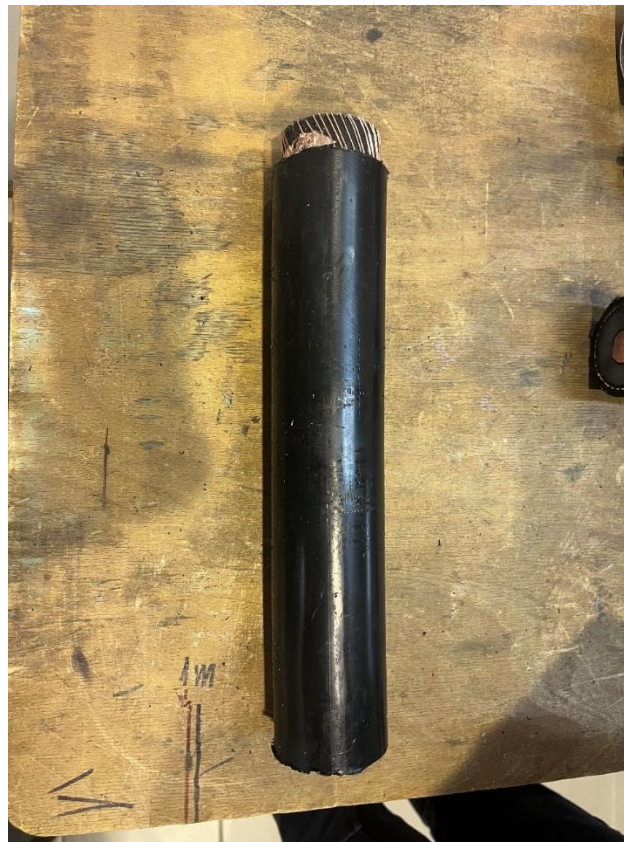
Figure 33. Type 2 cable.

Upon receipt of the cable specimens, the preparation process began by selecting a representative length of approximately 35 cm per sample, matching the dimensions used for other dielectric-strength tests. The specimen underwent careful stripping of its outer layers according to the methodology described in the preceding chapter. In particular, the tip region from which a jacket ring had been previously removed (as detailed earlier) was inspected to confirm that the jacket removal was clean and that the semiconducting screen and insulation interface remained intact. As seen in Figure 33, the stripped core, comprising concentric copper conductors and semiconductive screen layers, was then examined for irregularities in cross-sectional geometry.

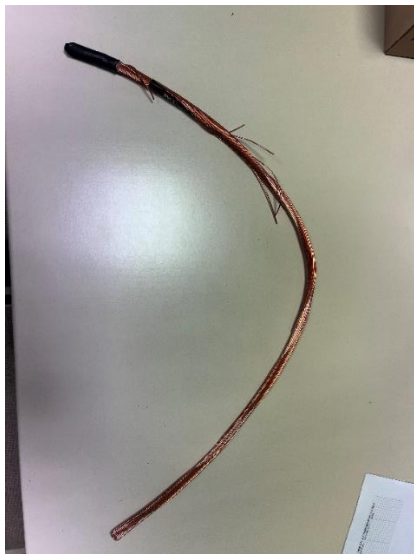
Figure 34. Copper ring.

Fabrication and attachment of copper ring terminals followed. Two rings (Figure 34) were formed from strands of the cable's own conductor material, cut and twisted into circular loops that would serve as electrodes and control rings during impulse application. One copper ring was positioned at the mid-length of the specimen, ensuring that it encircled the conductor assembly without compressing the insulation. The second ring was placed near the end where the jacket had been removed, aligning with the location of the striped tip. Each ring was secured tightly against the outer semiconductive screen, using fine copper wire to ensure consistent electrical contact around the circumference. Care was taken to avoid nicking the underlying insulation (Figure 35); protective gloves and appropriate pliers were employed during these manipulations.

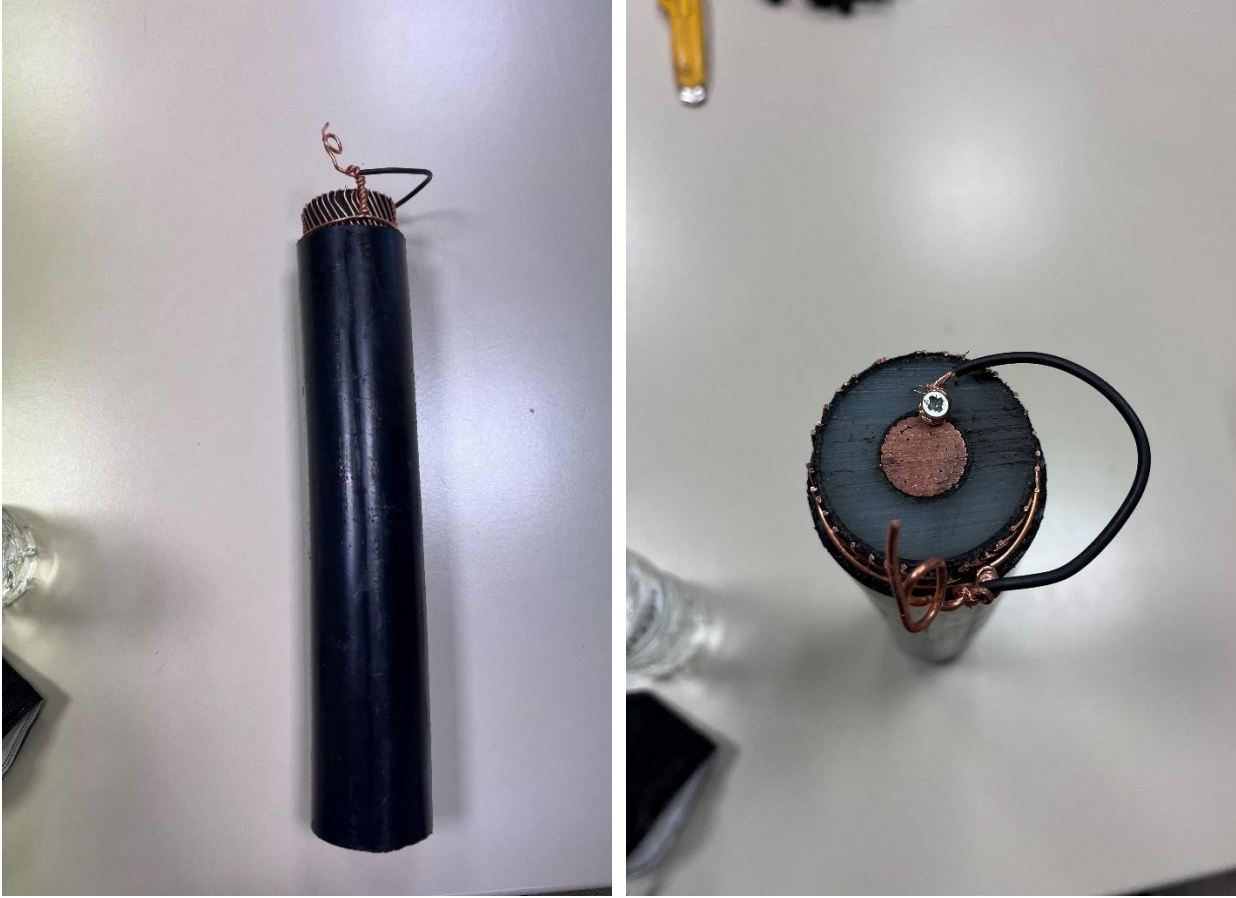
Figure 39. Potentials equalization modification.

Prompted by these observations, what was hypothesized was that unintended resistance or current leakage paths were affecting the impulse waveform. One possibility considered was surface discharge between the semiconductive screen and the conductor core. To address this, an attempt was made to equalize potentials between screen and core. A metallic screw was inserted through the insulation near the mid-region (taking care not to damage the primary dielectric), and a short jumper cable was connected between this screw and the copper ring or core connection. The intention was to force the voltage gradient between screen and core to zero, in an effort to suppress the discharges along that interface.

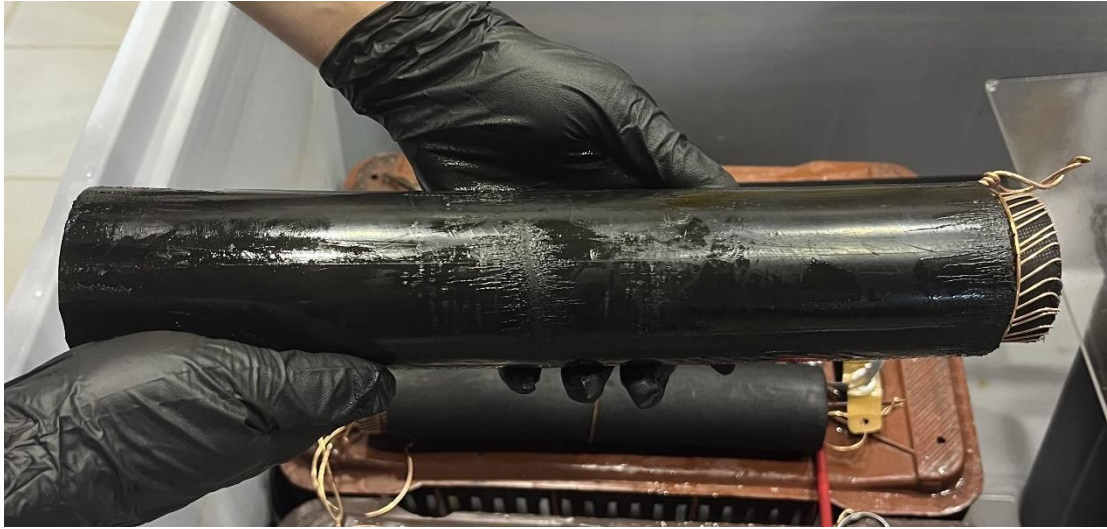
Figure 40. Cable after surface discharge.

Despite this intervention, subsequent impulse shots (Figure 37) still displayed the accelerated tail and audible signs of discharge. On inspection after the test, the specimen's surface exhibited burn marks and erosion consistent with surface (creepage) discharge. Photographs of the affected region revealed distinct channels of damage radiating from the copper ring toward the adjacent ends, confirming that the discharge had traversed the surface of the jacket material rather than occurring through the intended oil gap alone (Figure 40).

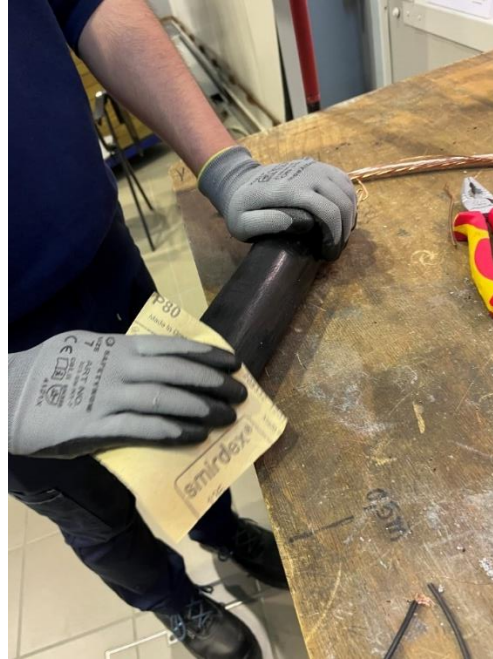
Figure 42. Sanding specimen.

In an attempt to restore a higher insulating resistance, the outer jacket surface was lightly abraded (Figure 42) using 80-grit sandpaper to remove any superficial conductive layer or contaminants. After sanding, the resistance was increased up to the level of $1500\ \Omega$. Despite this

increase, further impulse shots still produced irregular waveforms and audible discharge events. The recorded waveforms continued to deviate from $1.2/50 \mu\text{s}$, with abbreviated tail times and erratic oscillations.

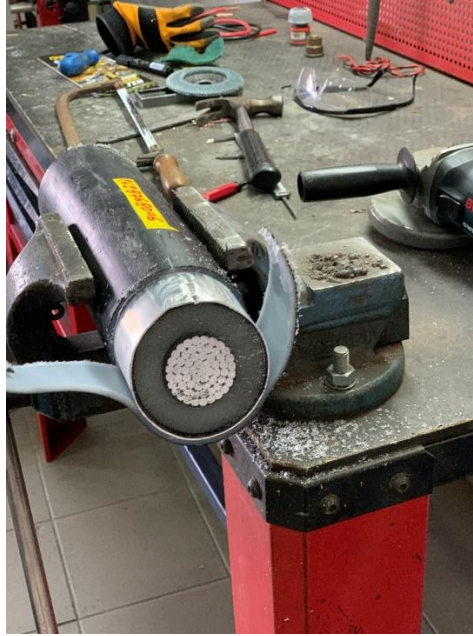
Figure 46. 150kV specimen with jacket ring removed.

The 150 kV cable specimen was prepared and tested under conditions intended to replicate service-relevant stresses, with careful attention to surface condition, electrode attachment, dielectric environment, and high-voltage impulse waveform fidelity. Initially, the outer jacket of the cable was stripped to expose the underlying layers (Figure 46). A circumferential ring of the outer covering was removed at one end, revealing the semiconductive screen beneath (Figure 45). Similarly, as per section 3.1, the presence of a substantial semiconductive layer was not yet fully realized.

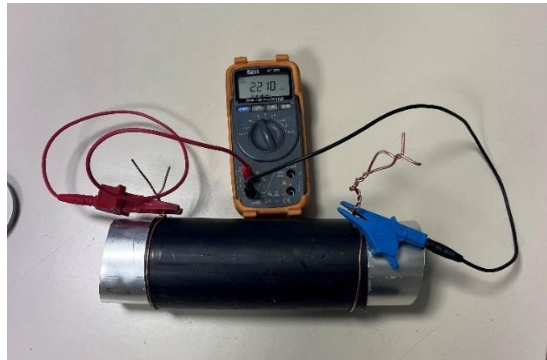
Figure 50. Resistance measurement for 150kV rated cable.

Such distortion indicated that the specimen surface was conductive under high voltage rather than behaving as a purely insulating barrier. To investigate the cause, the surface resistance was measured between the mid-length ring and the end ring using a precision ohmmeter. The measured

resistance was in the order of a few $K\Omega$ for the 35 cm specimen, confirming a conductive or semiconductive path along the jacket surface (Figure 50).

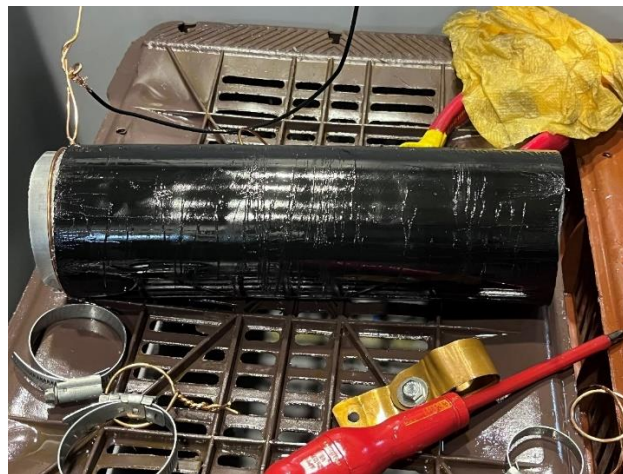
Figure 51. Burned jacket of specimen zero.

Visual inspection after the impulse revealed carbonization traces of the outer layer indicative of creepage discharge. Photographs taken immediately after the impulse showed carbonized traces and localized damage where surface currents had discharged, confirming that the semiconductive jacket had permitted leakage currents and partial breakdown under the applied stress (Figure 51).

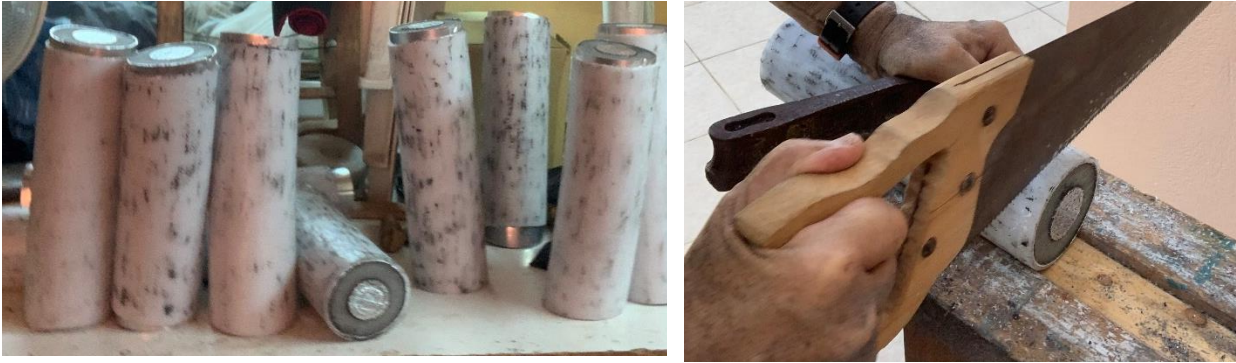
Figure 52. Removal of semiconductive layer and specimen preparation.

Recognizing that the semiconductive layer extended through a significant thickness—approximately two millimeters—mechanical removal was undertaken. Initial abrasion with coarse sandpaper proved insufficient, as residual semiconductive material remained and surface resistance stayed too low for valid impulse testing. A rasping tool was employed to scrape away the entire semiconductive layer uniformly around the circumference, exposing the underlying insulating material. During this process, the specimen was securely clamped to prevent movement,

and care was taken to remove the layer evenly without nicking the insulation beneath. After rasping, the surface exhibited a consistent matte appearance, free of the black semiconductive film (Figure 52).

Following the semiconductive layer removal, the surface resistance measurement was repeated (Figure 53), where in the resistance was increased dramatically into the $G\Omega$ range, indicating that the exterior now behaved as a high-quality insulator. This change in surface resistivity confirmed that the semiconductive path had been properly removed. With the insulation surface restored to a nonconductive state, the specimen was reassembled for testing.

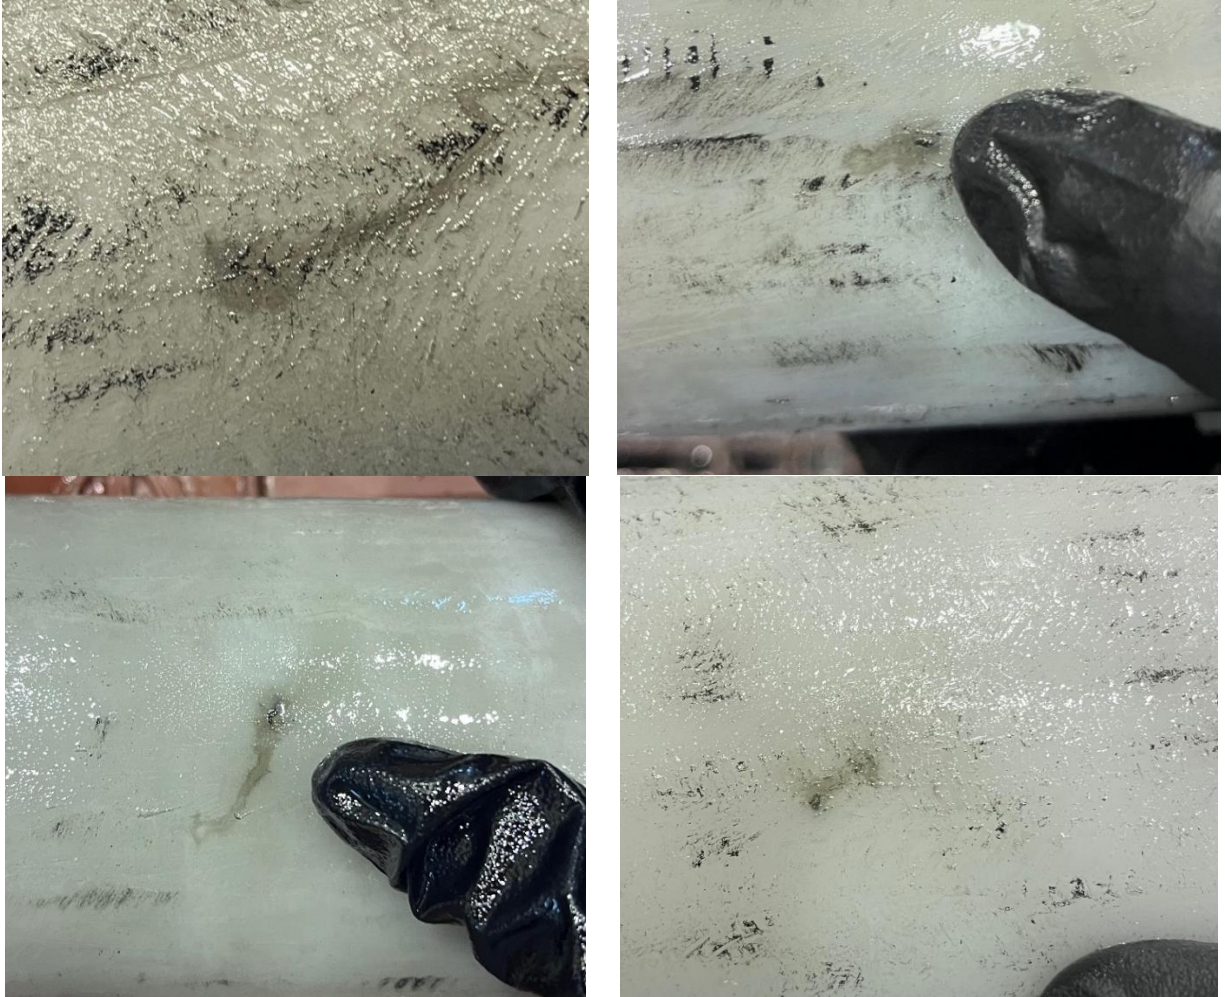
Figure 54. Examples of jacket insulation failures.
