Modelling, identification and structural damage investigation of the Neoria monument in Chania

The structural behavior of Neoria masonry monument is studied here. The determination of structural and material properties of a partially collapsed monument and the evaluation of existing damages and their importance for further restoration studies are not trivial tasks. The investigation has been based on detailed geometric data, collected from sources and in-situ measurements. For the mechanical analysis, finite element models have been created with different level of detail, including simplified description of documented damages. Modal analysis is assisted by micro-tremor measurements. Comparison of the predictions with the experimentally measured quantities, allows the determination of material parameters with higher accuracy. A least square technique assisted by the modal assurance criterion has been used, by driving the model from a Python script. A comparison of collapse predictions based on modified pushover analysis, with classical modal analysis has been performed. An explanation of existing damages is attempted, based on the numerical models.

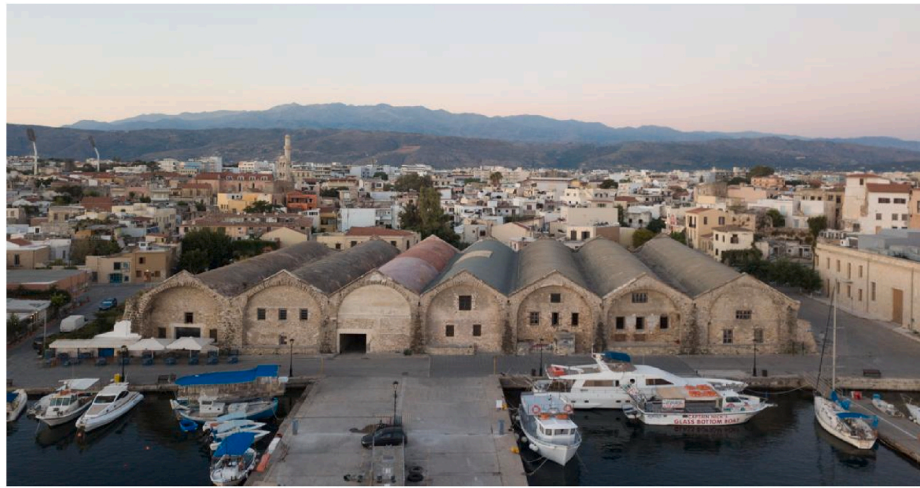
Fig. 1. The Neoria monument (Providakis, 2021).

In the present paper, the structural analysis investigation of the Neoria masonry vaulted structure at the Venetian harbor of Chania is presented (Fig. 1). Data related to the structure, the material, the damages and the foundation have been collected during a recent research project (Providakis, 2021). The accurate representation of the geometry of the vaults and the spandrels is necessary in order to model the existing condition including permanent deformations, loose material, cracks (Stavroulaki et al., 2016). This is important for the estimation of the structural strength and dynamic behavior considering the three dimensional, effects of the vaults and the stabilization role of the spandrels (Stavroulaki and Tsinarakis, 2011).

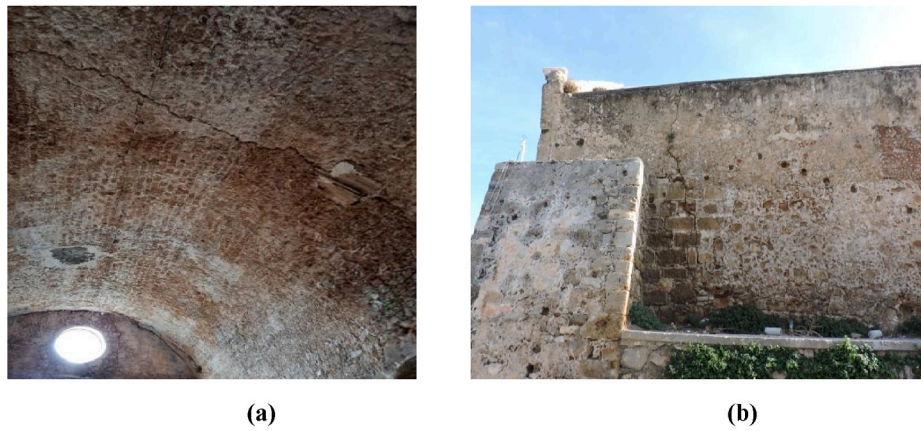
Large width cracks of the inside of the vaults and on the west wall are illustrated in the followed Figures (Fig. 12 (a) – (c))

Fig. 12. Crack on vault. (a) Inside and (b) outside view. (c) Biological deterioration on the North Wall.

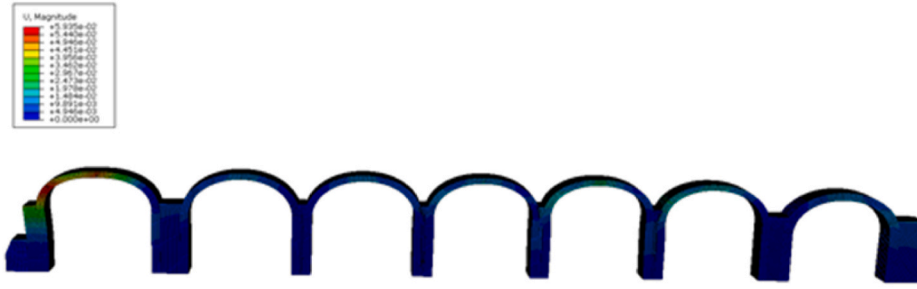
Fig. 19. The displacement contour of the whole structure under gravity loads.

The failure mechanism presented are shown in Figs. 18–20 correlate with the longitudinal cracks observed on the structure in-situ and the damage pattern is similar to the one observed in the limit state analysis. Also, the model with one arch has a similar failure pattern with the full structure of 7 arches, even though the failure pattern is exaggerated on the one arch model. The hinge circled in yellow in Fig. 19 (model with one arch) and Fig. 20 (full structure) shows an outwards opening, respectively. For the model with the full structure, there is an influence of the adjacent arch to the first arch, which acts as a probe which prevents/minimize the lateral movement of the arch. This tends to minimize the overall displacement of the structure making it more stable.
